AIR SERVICE INFORMATION CIRCULAR

December 1, 1922

STATIC TEST OF THE DAYTON WRIGHT TA-3 AIRPLANE

Prepared by A. L. Morse
Engineering Division, Air Service
McCook Field, Dayton, Ohio
July 15, 1922

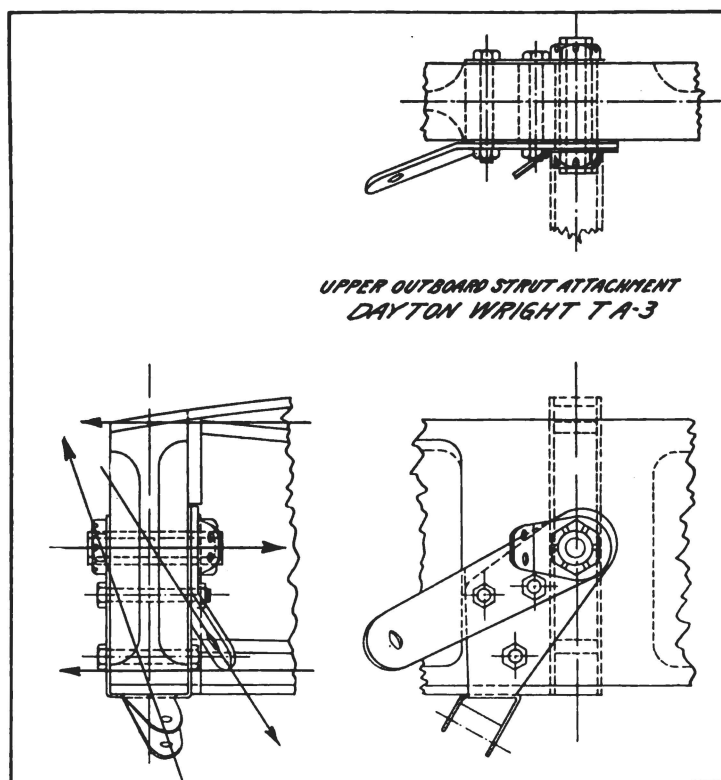
FIG. 14.

The wings were required to support a load factor of 8. The failure seems to have been caused by the combined effects of longitudinal shear and a couple due to the eccentric forces of the interplane strut and the drag and lift wires. Figure 14 shows the conditions at the point of failure.

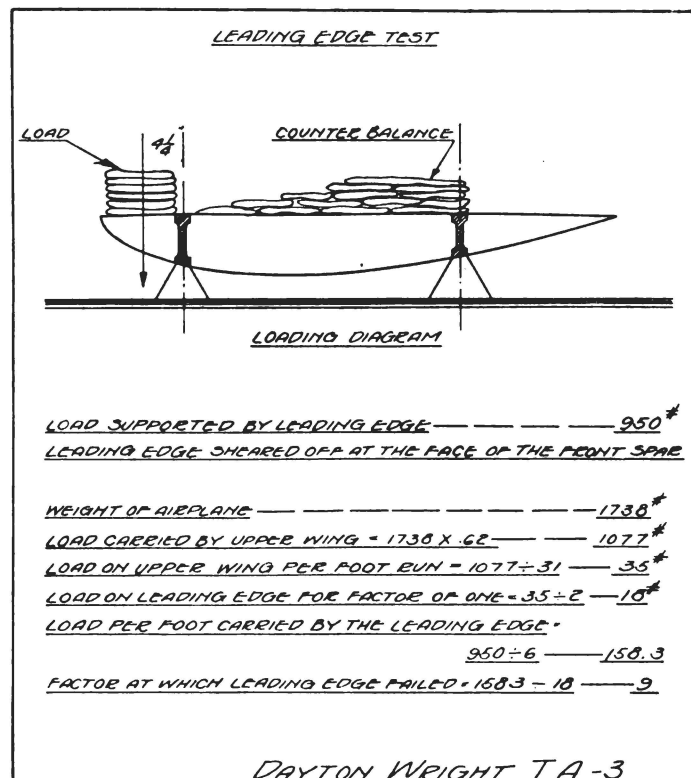
FIG. 27.

At a load factor of 9 the leading edge sheared off at the face of the front spar. Figure 27 gives the result of the leading edge test.

The leading edge was required to support a load factor of 14. It failed at 9.

It is recommended that the leading edge be strengthened.

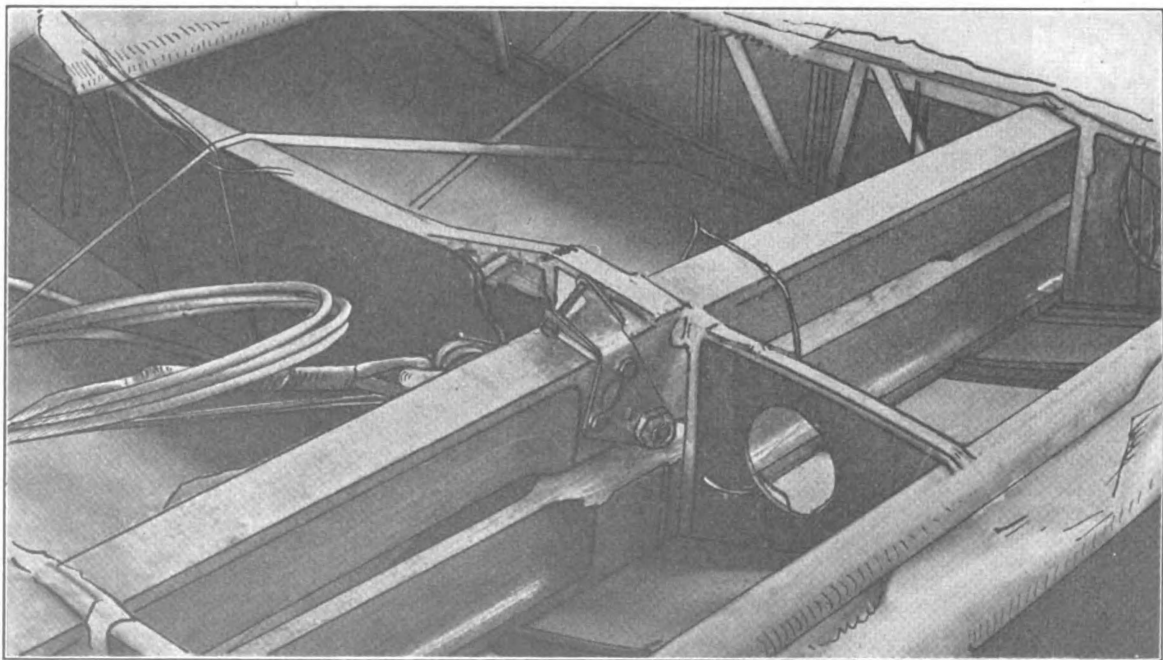
FIG. 30.

The wings failed at a load factor of 6 in the following manner: The forward spar of the right upper wing split longitudinally through the routing. The split was about five feet long and appeared to have originated at the point of the interplane strut attachment. The lower half of the spar, at this point, was rotated axially and clockwise, as seen from the pilot's seat, crushing the light plywood sides of the compression rib. Figure 30 is a photograph

Because of this local failure no conclusions could be drawn as to the strength of the wings as a whole, so it was necessary to strengthen the parts in the locality of the failure and conduct a new test.

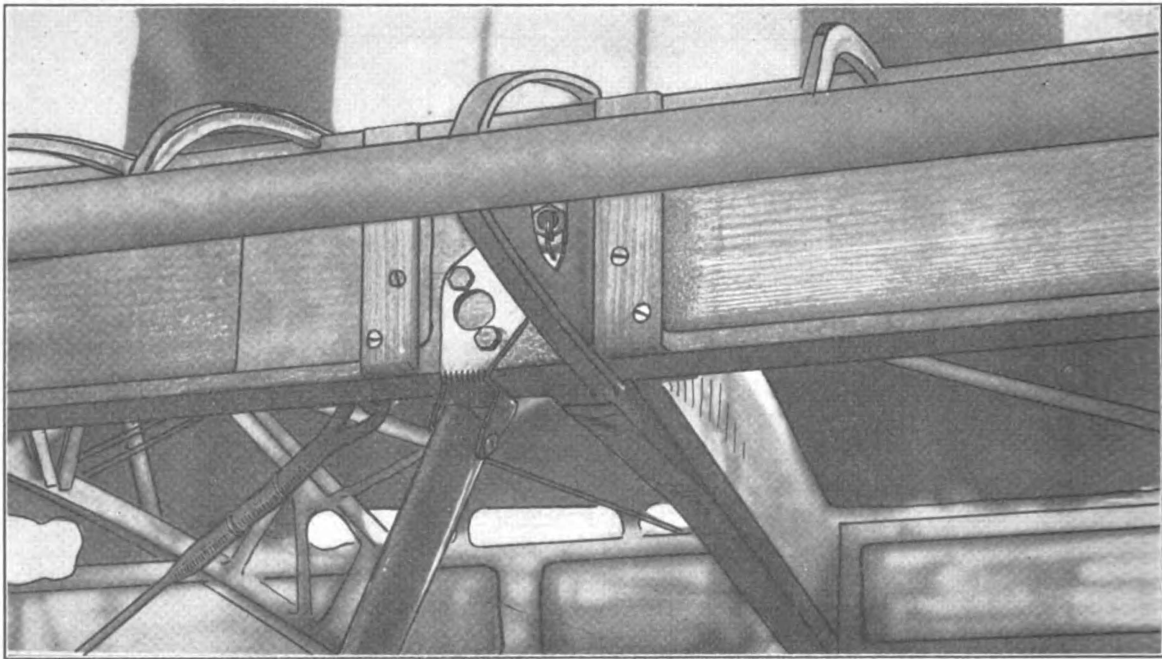
FIG. 31.

The procedure was the same as in the first test. The loading schedule may be seen in Figure 15. The repairs and additions to the wings were as follows: The front spars were stiffened by $\frac{1}{8}$ -inch by $1\frac{1}{4}$ -inch oak blocks. Four of these were screwed to the sides of the spar on either side of the interplane strut attachment fitting front and rear. The routing was filled with spruce blocks where necessary. The compression ribs were reinforced by a $\frac{1}{4}$ -inch by $3\frac{1}{2}$ -inch white pine member placed against the outboard side of the compression rib. The right upper and lower wings were interchanged. Figure 31 shows the repairs.

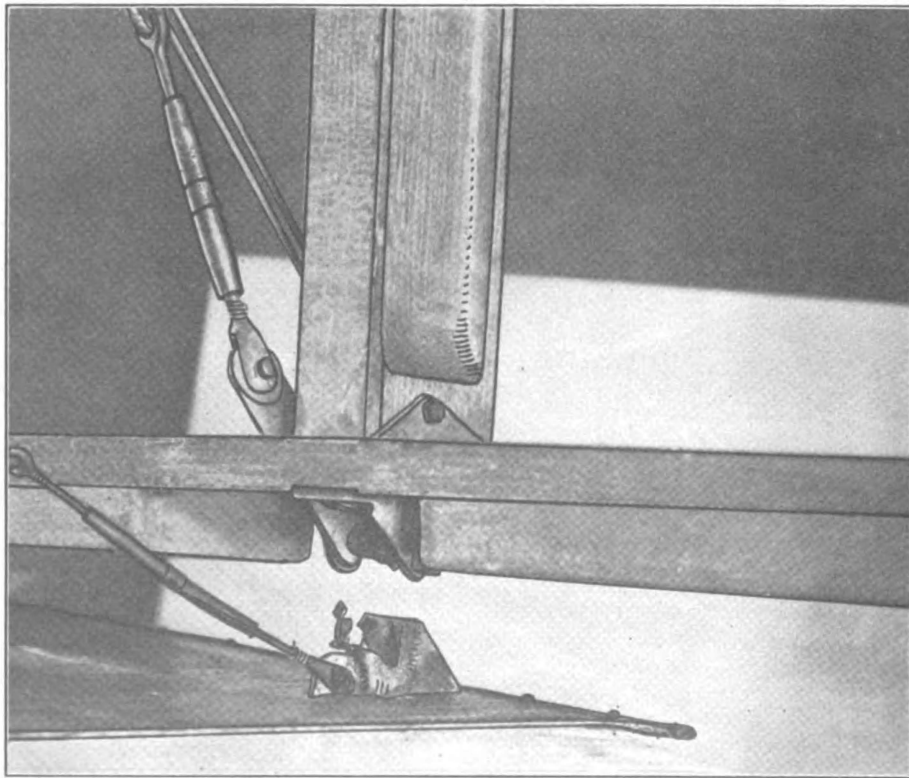
FIG. 32.

The wings failed at a load factor of 8. The lower right rear wing spar attachment fitting at the fuselage pulled out while the jacks were being let down. Figure 32 is a photograph of the failure. Figure 16 is a table of spar deflections and Figure 17 shows the deflection curves. After the test the forward center section support fittings were found to have been torn. Figure 33 and 34 show this failure.

The wings were required to support a load factor of 8. The above fitting pulled out before the wings fully supported this load.

It is recommended that the lower rear spar attachment and that the upper wings in the region of the interplane strut attachment be redesigned.

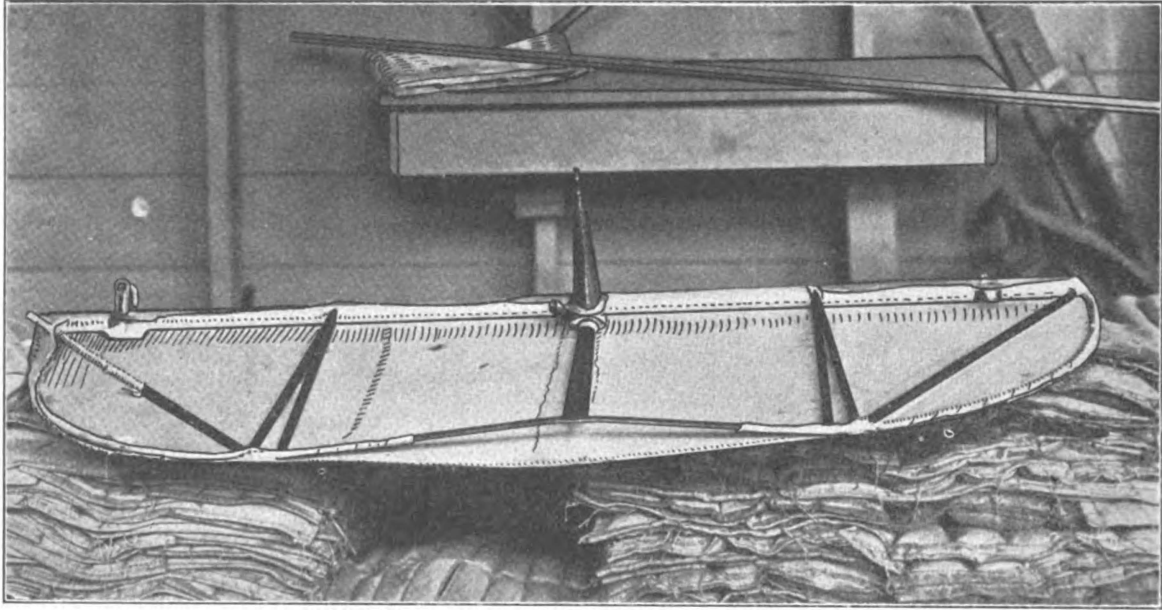
FIG. 35.

Figure 19 shows the deflections and results of the test. The horizontal tail surface stood the test without failure. They were loaded up to 40 pounds per square foot, after which a permanent warp in the trailing edge was noted. Figure 35 is a photograph of the warped trailing edge.

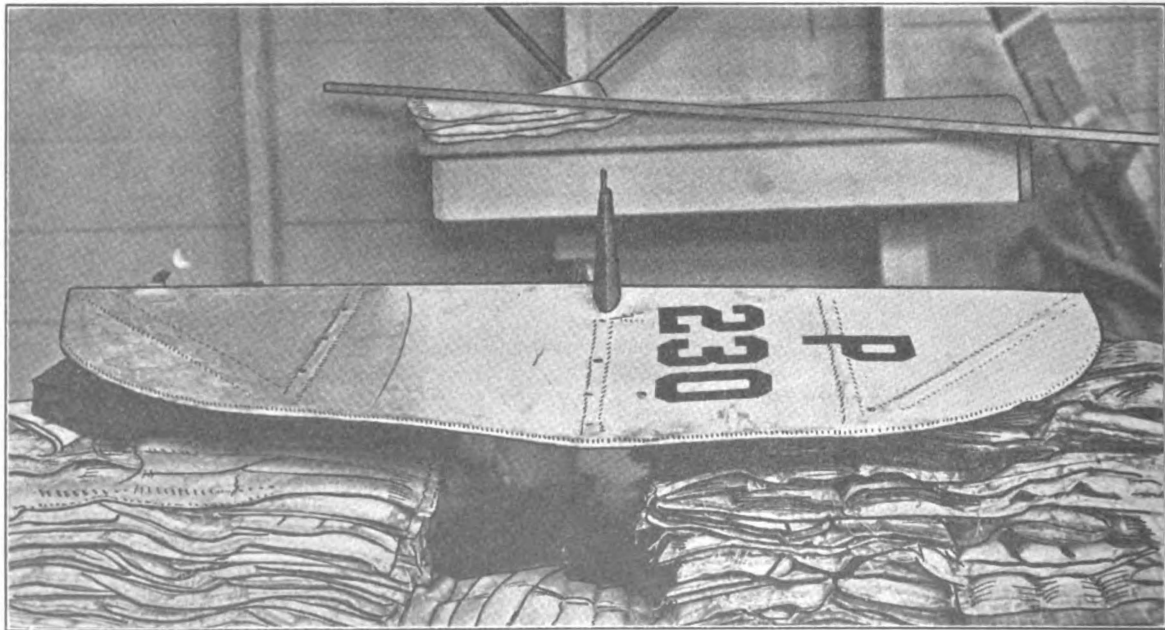
FIG. 36.

Figure 21 shows the deflections and results of the test. The rudder and fin were loaded up to 60 pounds per square foot without a failure, after which a permanent warp in the trailing edge was noted. Figure 36 is a photograph of the warped trailing edge.

It is recommended that the rudder and fin be redesigned.

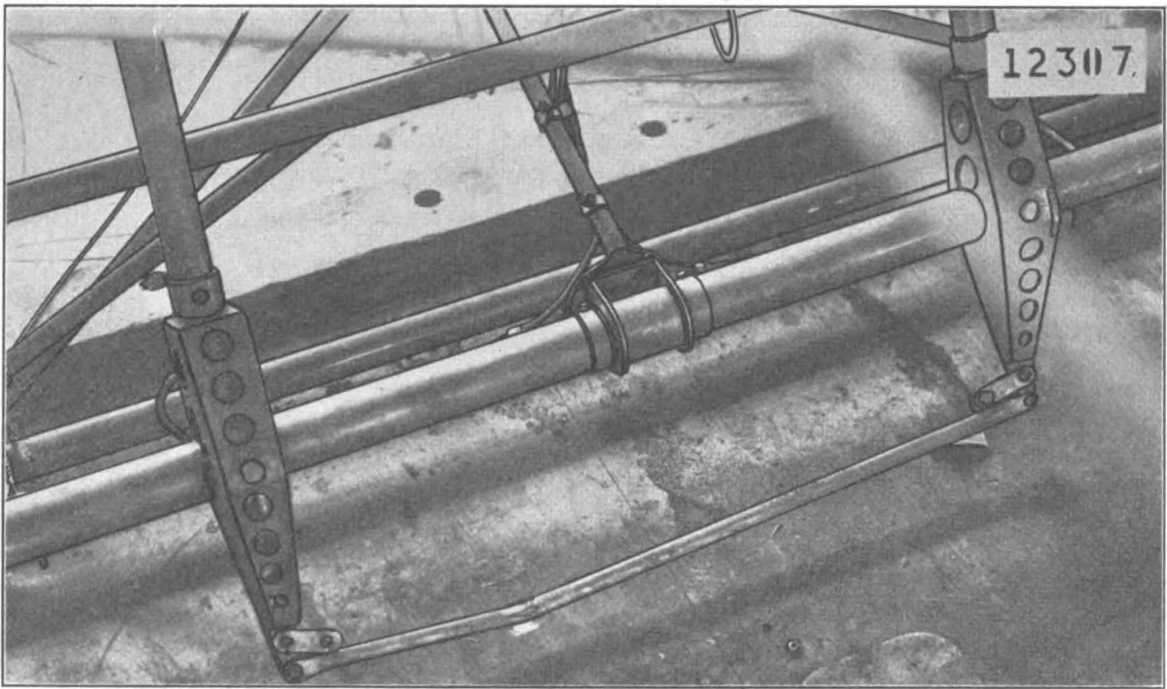
FIG. 37.

Figure 23 shows the results of the test. At a load of 10 pounds per square foot there was an excessive deflection in both ailerons. At a load of 20 pounds per square foot the link connecting the twin control sticks buckled. Figure 37 is a photograph of the failure of the connecting link. The triangular bell-crank lever support pulled away from the spar. Figure 38 is a photograph of this failure.

Since the abnormal deflection was due largely to the design of the control system, and since the control system failed so soon, no conclusions can be made as to the structural strength of the ailerons. It is evident, however, that the control system is weak.

It is recommended that the control mechanism be redesigned.

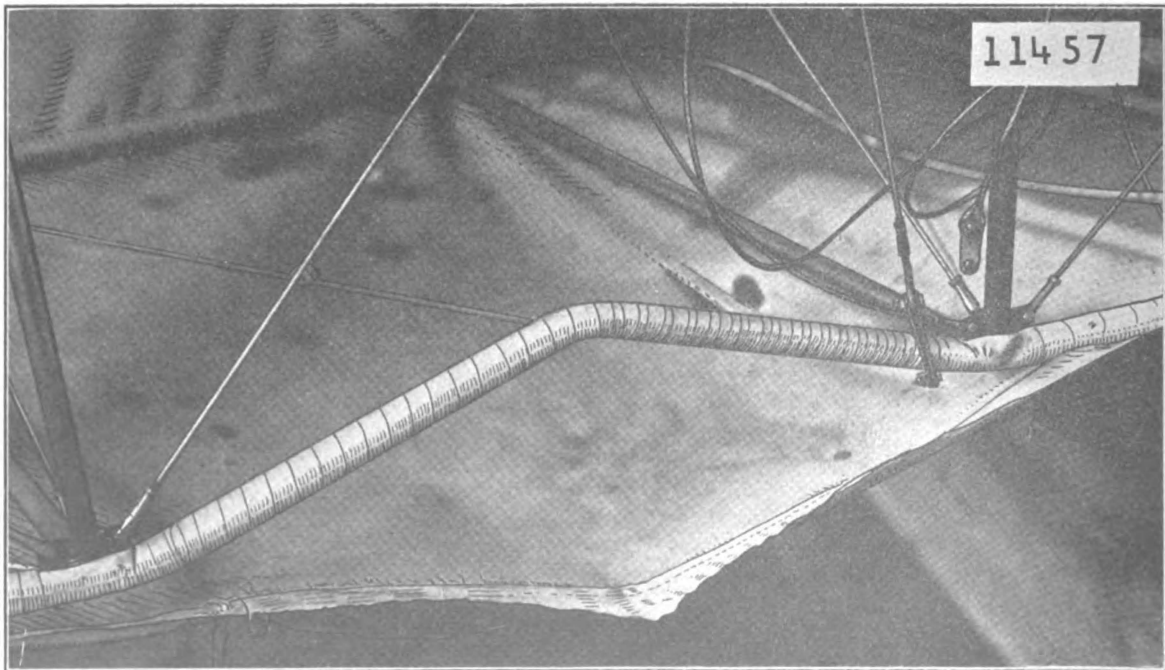
FIG. 40

The fuselage failed at a load factor of 10. The lower right longeron two bays back of the cockpit failed by buckling. Figure 26 shows the results of the fuselage test. Figure 40 is a photograph of the longeron failure.

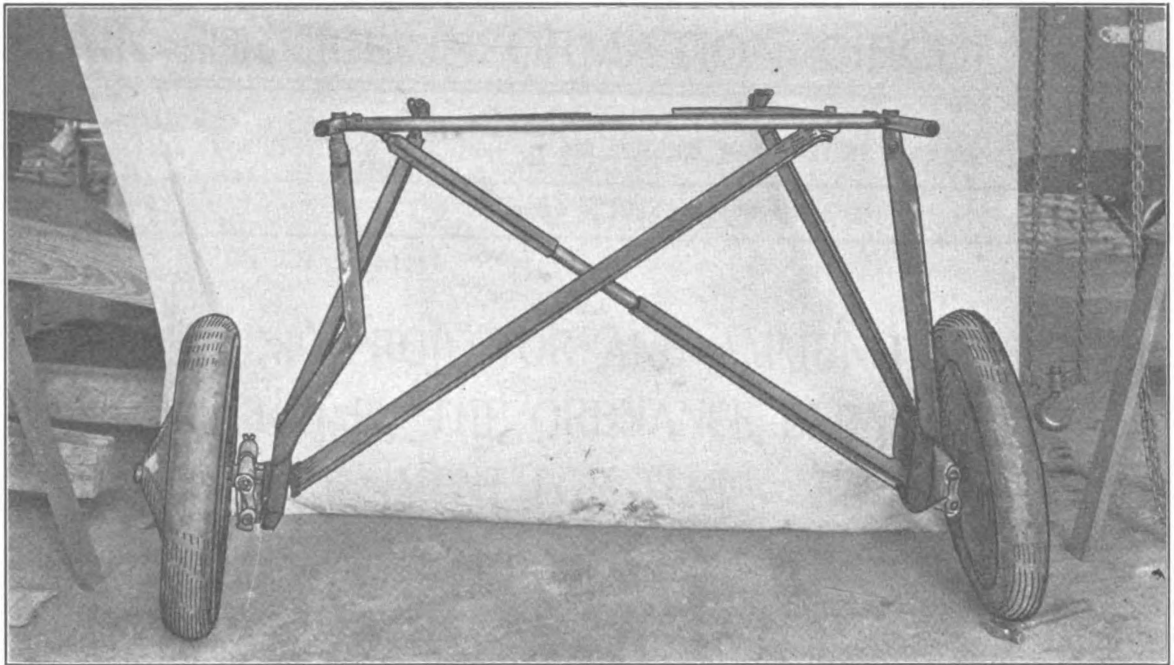
FIG. 41.

The landing gear failed at a load factor of 6. The left rear strut buckled. As the shock absorbers deflected the axles moved laterally in the cradles $1\frac{1}{4}$ inches. The results are tabulated in Figure 29. Figure 41 is a photograph of the failure.

The landing gear was required to support a load factor of 7.5. The lateral movement of the axles would undoubtedly severely stress the wheels.

The landing gear did not support the required load in a satisfactory manner.

It is recommended that the landing gear be redesigned.

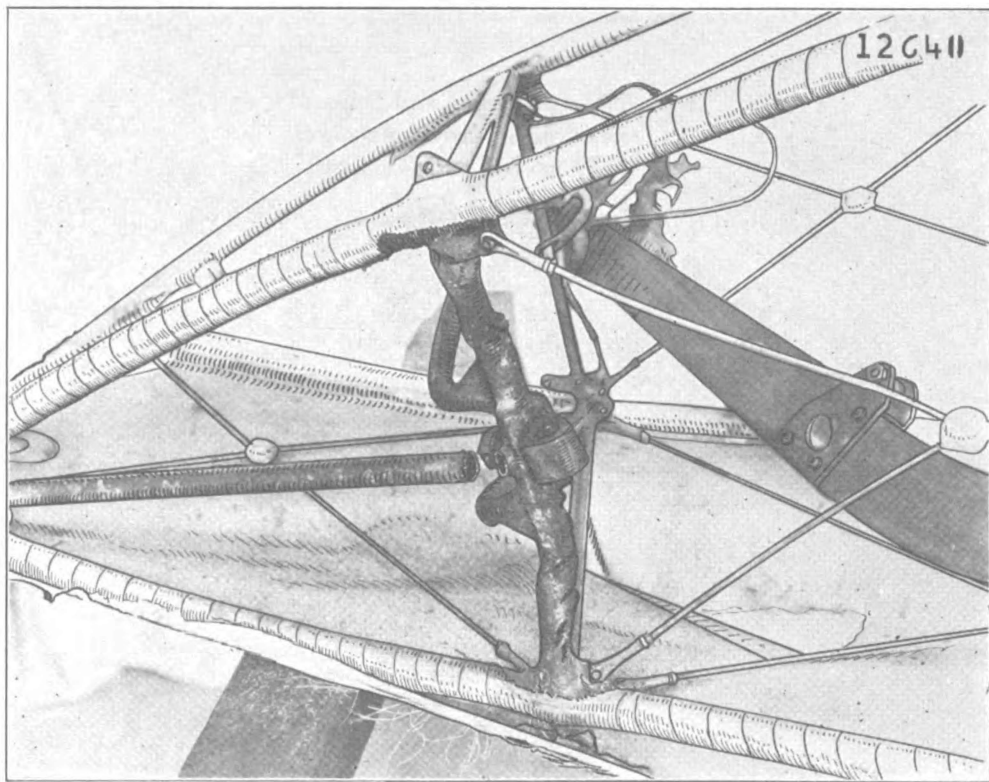
FIG. 42.

When the tail skid was dropped from a height of 18 inches the following failures occurred: The cross tubes of the fuselage to which the swivel was attached was rotated forward and upward, deforming the two vertical members of the reinforcing tripod and breaking the horizontal member. The skid itself was slightly cracked. Figure 42 is a photograph of the failure.

The tail-skid support did not meet the requirements in a satisfactory manner.

It is recommended that the fuselage in the vicinity of the tail skid be redesigned.
